**NOTICE OF VIOLATION**

**VIOLATION OF WASTE DISCHARGE REQUIREMENTS ORDER 99-004, MARIPOSA COUNTY DEPARTMENT OF PUBLIC WORKS, YOSEMITE WEST MAINTENANCE DISTRICT WASTEWATER TREATMENT FACILITY (WDID 5C221002001, RM 387091, MARIPOSA COUNTY**

5C221002001      99-004      **FACILITIES INSPECTION REPORT**      145594      1/7  
 WQID      ORDER NO.      REG MEASURE ID      PAGE NO.  
 N15           27813      274513  
 PROGRAM      NPDES PERMIT NO.      PARTY ID      PLACE ID

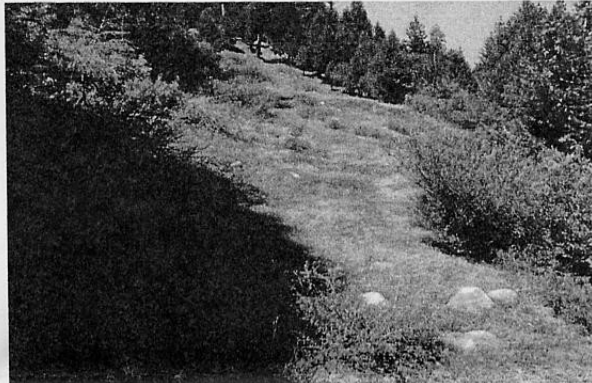
Photo 8. Leachfield area

I inspected the leachfields and subsurface drip irrigation area. The leachfields are numbered 1, 2, 3a, 3b, 4, 5, and 6.
